ventura county california

Survey Report for Beach
Erosion Control

main report

U.S. Army Corps of Engineers Los Angeles District

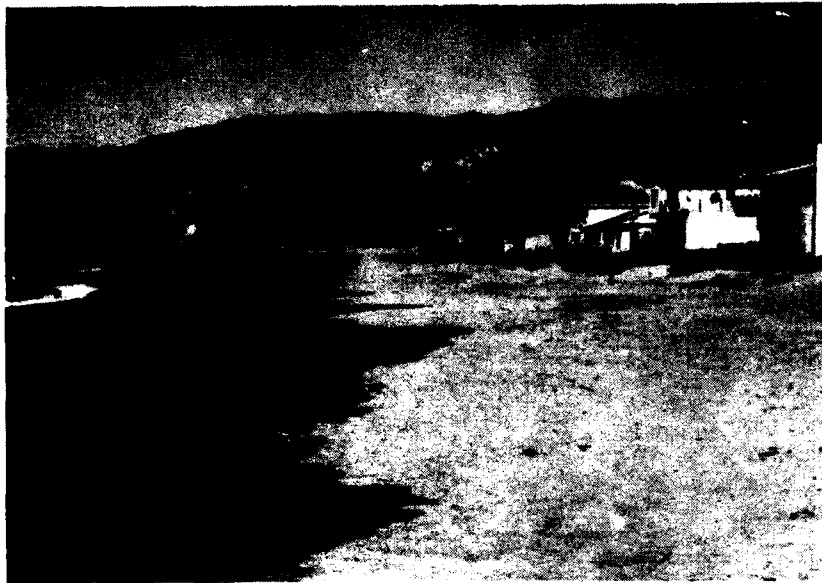
Upcoast view of Mussel Shoals, Dec. 2, 1976

The beach at Mussel Shoals has the usual seasonal fluctuation of onshore accretion of sand in the summer and erosion in the winter. The 1977-78 winter storms caused an unusually high degree of erosion and threatened five homes. Rock revetment was placed to protect these homes at a cost to each homeowner of about \$4,000.

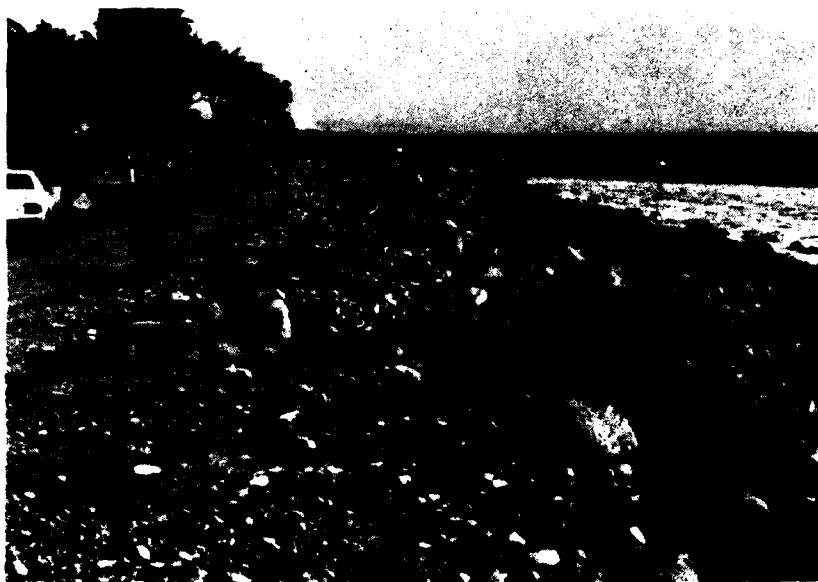
Downcoast view of Faria Park, Mar. 15, 1978

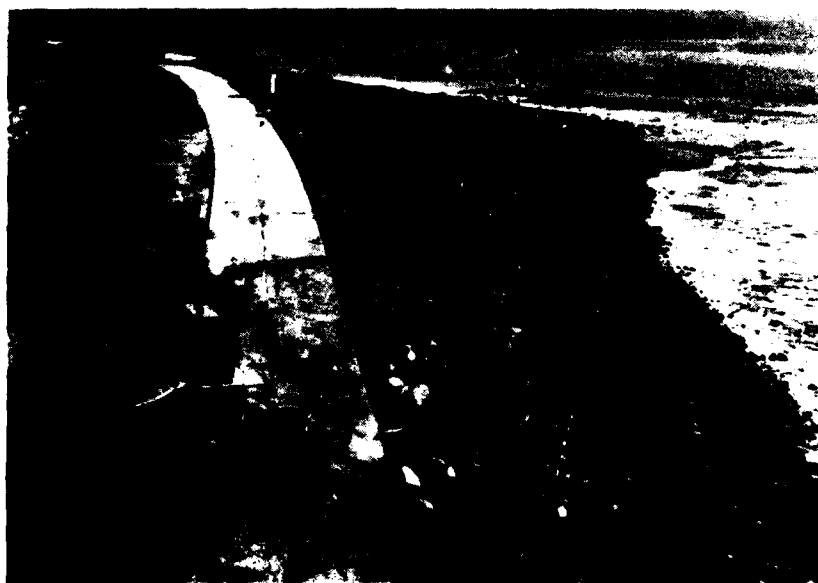
Downcoast view of Emma Wood State Beach, Mar. 15, 1978

Park performed satisfactorily in the recent storms of the winter of 1977-78, with only small stones being displaced in the parking areas. Caltrans has also recently repaired the old highway revetment from Hobson Park downcoast to Emma Wood State Beach, which was damaged by the winter of 1977-78. The State of California Parks and Recreation Department has constructed a rock revetment to protect the entrance road leading into Emma Wood State Beach. Immediately downcoast from the south jetty at Port Hueneme, the U.S. Navy has constructed a massive rock seawall to protect its property from flooding. Also, at the Point Mugu Naval Air Station, a groin field and rock revetments have been constructed by the U.S. Navy to protect the military and recreational facilities.

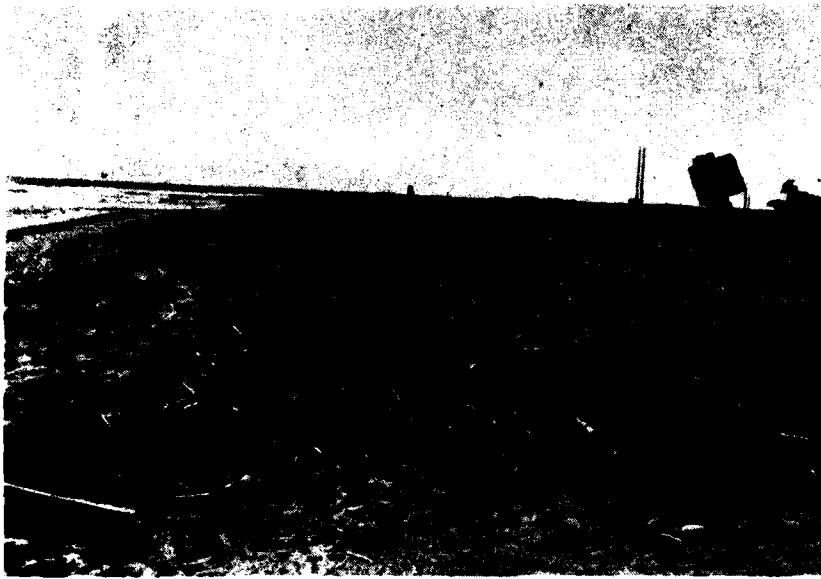
The following photographs generally show the debris and denuded conditions of the beaches in the central coast subregion immediately after the winter of 1977-78 storms.

Upcoast view of 31st Agricultural District Association, Mar. 15, 1978

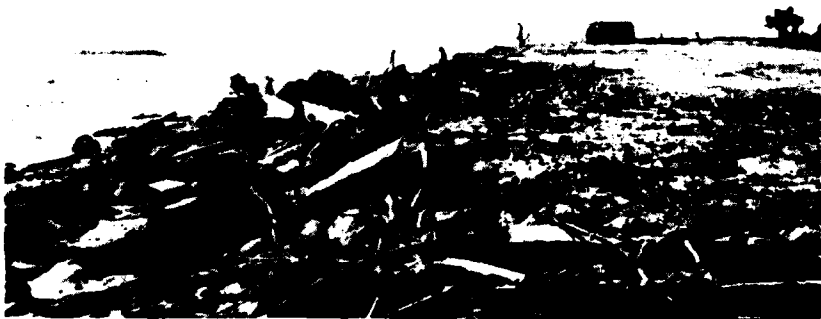
Upcoast view of Surfer's Point Park, Mar. 15, 1978

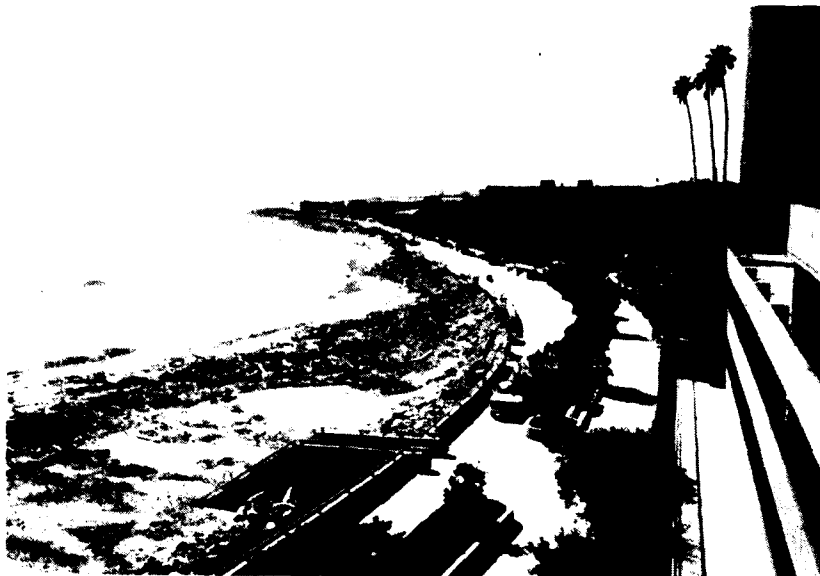
Upcoast view of Surfer's Point from San Buenaventura State Beach,
Mar. 15, 1978

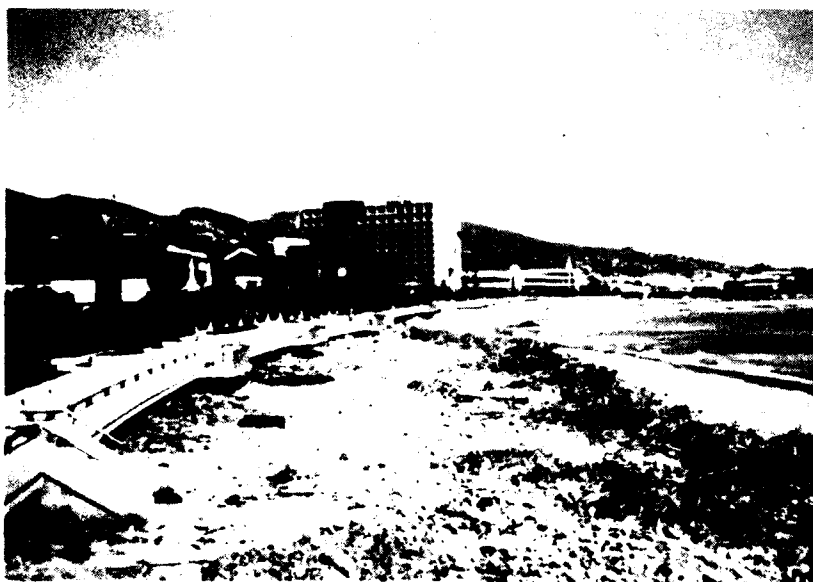
Downcoast view of San Buenaventura State Beach from Surfer's Point,
Mar. 15, 1978

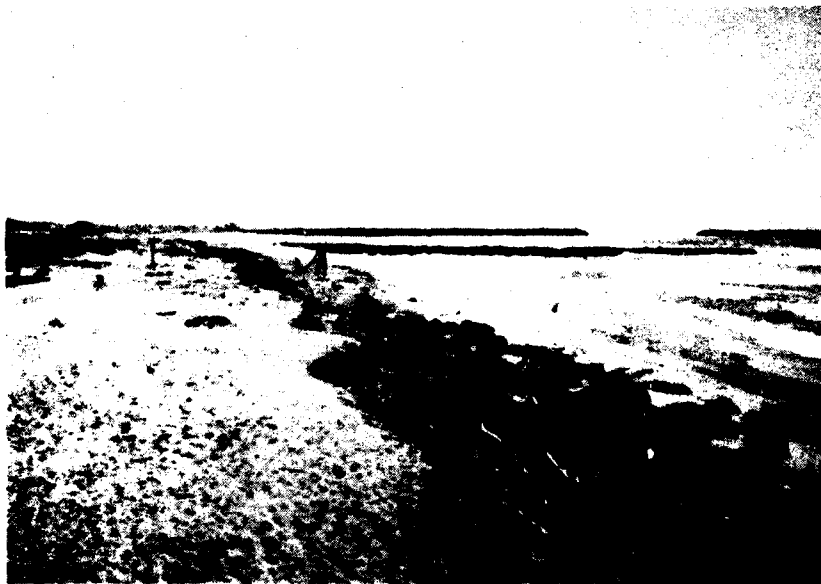
Downcoast view of groin no. 1, San Buenaventura State Beach,
Mar. 15, 1978

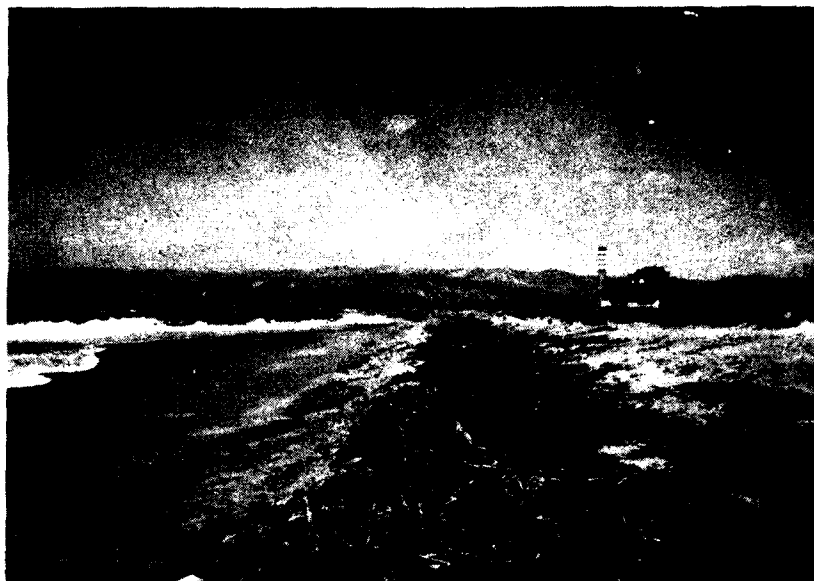
Upcoast view of Mandalay Beach Park Mar. 15, 1978

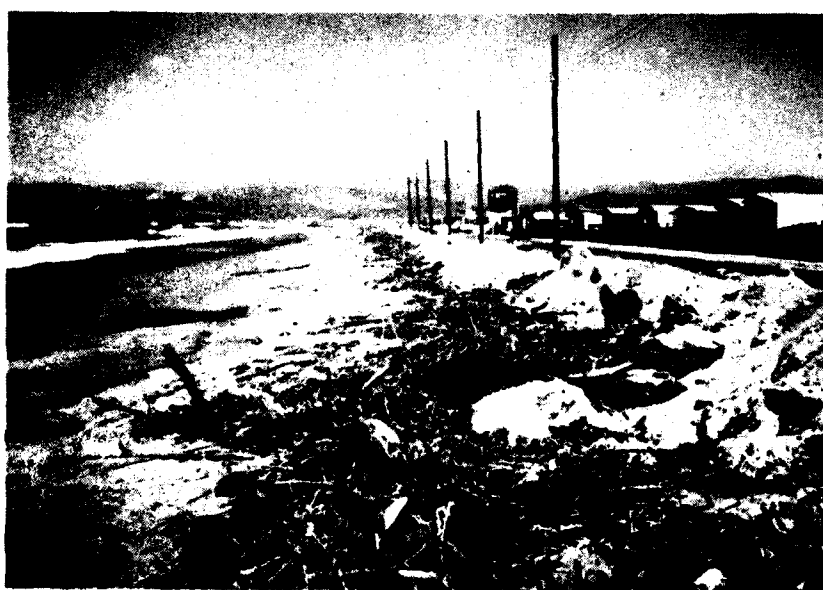
Upcoast view of northern part of Oxnard Shores
adjacent to Mandalay Road, Mar. 15, 1978

Oxnard Shores has been repeatedly attacked by waves, and some homes have been destroyed or severely damaged. Private citizens have attempted various shore protection devices to protect their homes, with varying degrees of success. Local interests have placed rock revetment on the upcoast part of Oxnard Shores that is adjacent to Mandalay Road to protect against the high wave action. Homes landward from the road have suffered inconveniences from wave action overtopping the berm and carrying sand and debris into the streets and yards. Three factors contributed to this problem: (a) at the time of the construction of these homes, the shoreline was probably at its most seaward position as a result of the 1938 floods; (b) protective dunes were removed; and (c) the houses were built on concrete slabs or on standard footings instead of on piles. The area was subsequently annexed by the City of Oxnard. The city now requires new construction to have higher floor elevations and to be built on piles. Since this time, damage to these homes has been minimal.

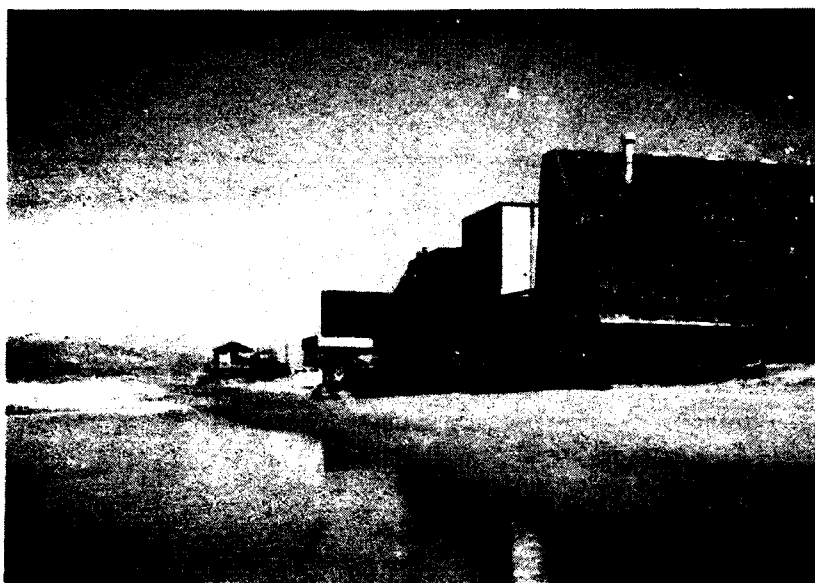
Upcoast view of Oxnard Shores, Mar. 15, 1978

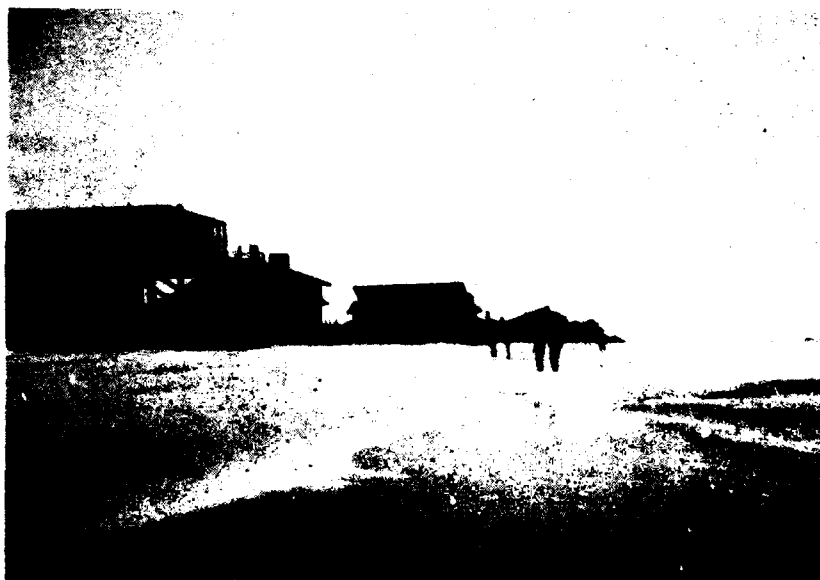
Downcoast view of Oxnard Shores, Mar. 15, 1978

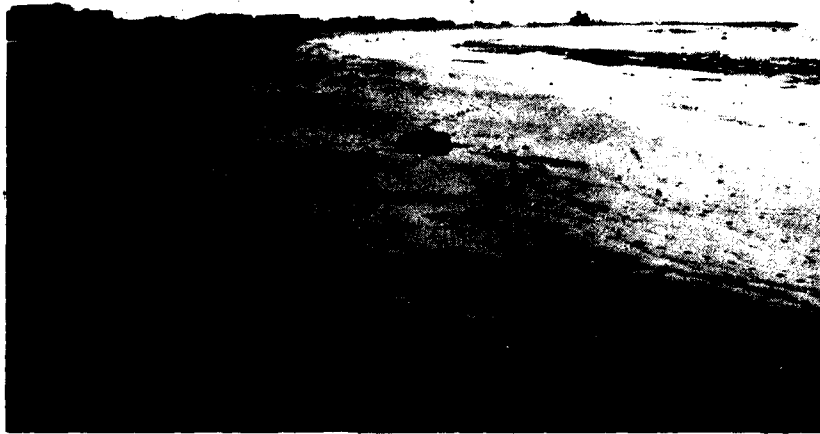
Downcoast view of Silver Strand Beach Park Dec. 2, 1976

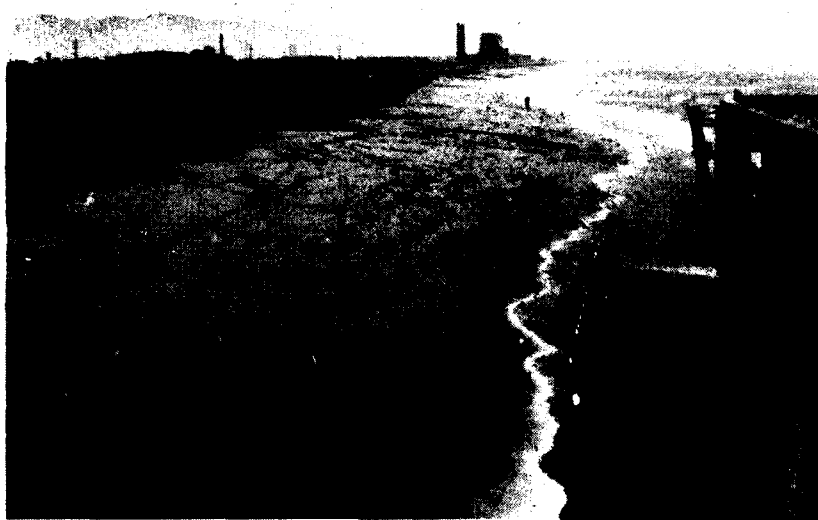
Downcoast view of Port Hueneme Beach, Mar. 15, 1978

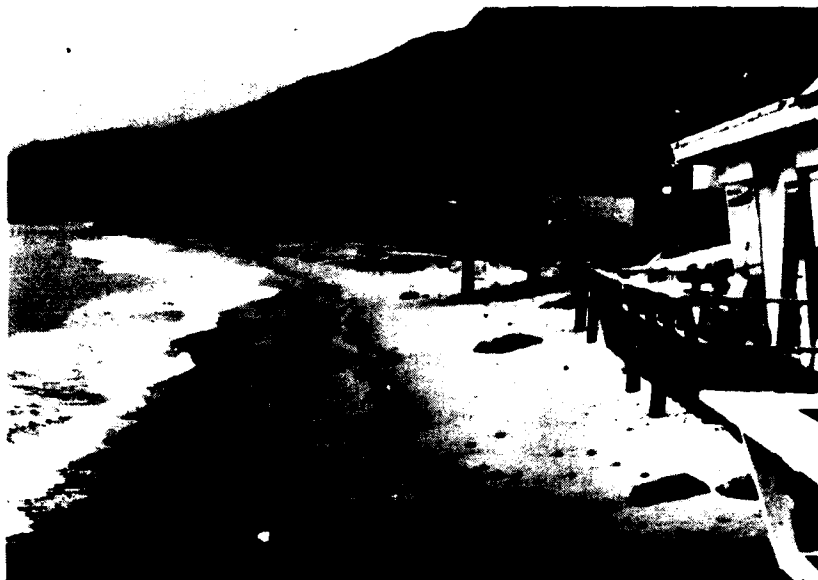
County Line Beach, a private beach 1-1/2 miles upcoast from the Ventura County-Los Angeles County line, suffered erosion (8-10 feet vertically) from the high wave action in September 1972. Seven out of eighteen homes suffered minor to severe damage from the waves. Volunteers placed sandbags to form protection. Approximately 500 tons of rock revetment were placed during this emergency at the owner's expense. This area has a seasonal fluctuation of sand, with its maximum accretion occurring in late summer. About 900 feet of the 2,000 feet of private beach shows a progressing erosion pattern.

Upcoast view of County Line Beach, Sept. 7, 1972

County Line Beach area (shown in the following photos) is a very important surfing area. This area, known to the surfing population as "Pete's Reef," was one of the first locations in Ventura County to be surfed. It is very important that surfing areas like County Line Beach have adequate parking and related facilities so that maximum recreational benefit is realized from these areas.
